A FLIGHT INVESTIGATION OF THE THERMAL PROPERTIES

OF AN EXHAUST HEATED WING DE-ICING SYSTEM

ON A LOCKHEED 12-A AIRPLANE

By Lewis A. Rodert and Lawrence A. Clousing

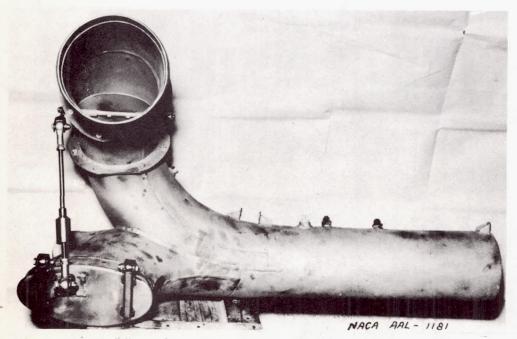
The double-ball joint between the wing tube and tail pipe has been found satisfactory. The double flanged elbow in the tail pipe (see fig. 5) allows a slight exhaust gas leakage, and when first put in service, several bolts were broken due to expansion. The gas leakage in the region of the elbow was counteracted by shrouding this section of the exhaust tube and venting the shroud to the air stream. The breaking of bolts is believed to have been due, in part, to initial tension, since, by not drawing the flange bolts down tight, further breakage has been avoided.

Figure 5.- The exhaust tail pipe and exhaust valve system of the left engine. As the butterfly valve in the elbow opens, the clapper valve over the normal exhaust port closes.

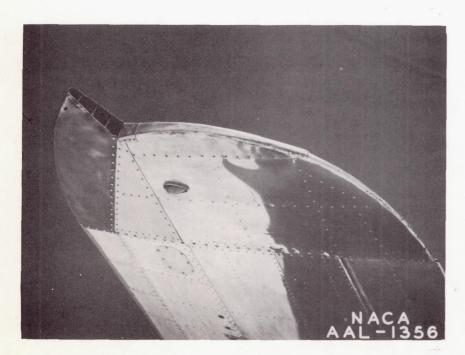
Vibrations in the semi-elliptical tip shroud (see fig. 11) caused a crack along the leading edge at the discharge end. Three stiffeners, which appear as vanes in the end of the shroud, were installed which prevented recordence of this failure.

Figure 11.- Exhaust heated wing tip. The exhaust gas is discharged from the wing tube into the leading edge shroud from which it passes to the atmosphere through the opening shown.
